Special Historic Site &
Special Place of Scenic Beauty
The Imperial Villa
Garden Site of
the Ancient Nara Capital

The Imperial Villa Garden Site of the Ancient Nara Capital displays the relics of a garden discovered during the excavation research in 1975. This garden with a pond dates from the Nara period (710-794). Since the garden is thought to have functioned as a villa of the Heijo Palace or a residence for imperial members, it was given the name Imperial Villa Garden Site of the Ancient Nara Capital.

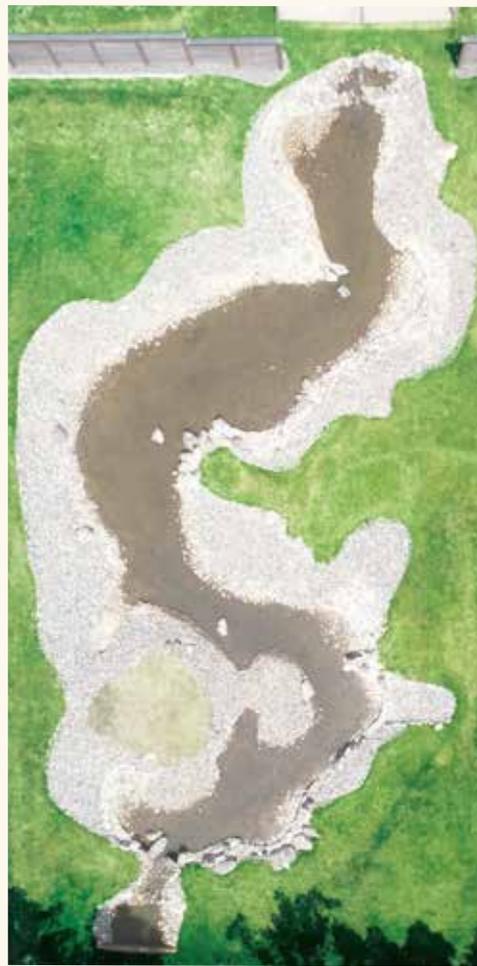
Panoramic view of the garden (upwards signifies north)

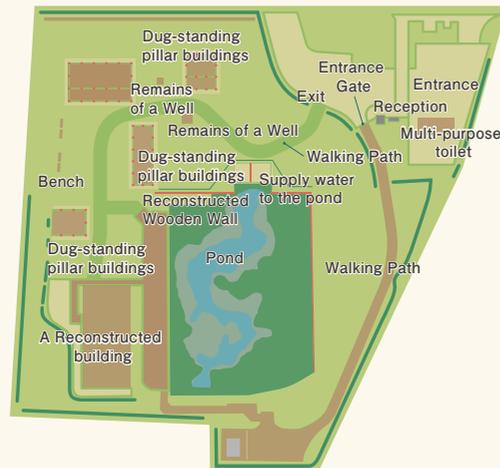
Layout of the Imperial Villa Garden

In the center of the garden was an S-shaped curving pond with cobblestones placed at the bottom. Buildings and walls were constructed on the west side of the pond. Looking out at the pond from the building, the eastern mountains, such as Mt. Kasuga and Mt. Mikasa, appeared as the perfect distant backdrop.

At the center of the garden is a pond with rocks. The bottom of the pond was paved with clay and flat stones of 20-30 cm in diameter were layered on it. Cobblestones were placed neatly along the waterline to mark the pond's outline. Another outer line was drawn with stones thereby producing a moderate inclination. The pond was shallow, only 20-30 cm in depth, and was fed by a slow-moving stream. There are different theories as to what the S-shape of the pond represents. Some say it symbolizes a dragon while others say it follows the shape of the Yoshino River flowing around the Miyataki area in Yoshino Town, Nara.

Large rocks are distributed where the pond curves sharply. Three large rocks are also situated in the pond as design accents to signify islands. There are two large wooden water basins set on the bottom where water plants grew.

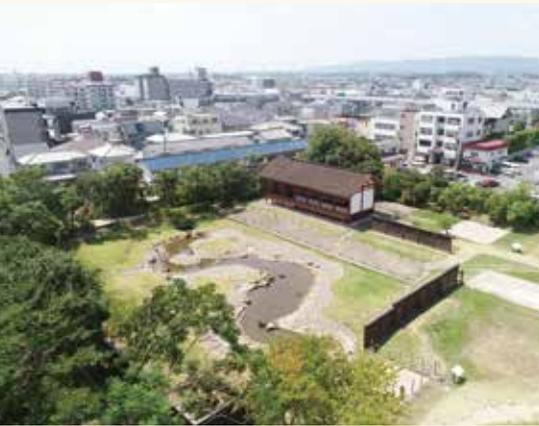
Birds-eye view of the Imperial Villa Garden Site

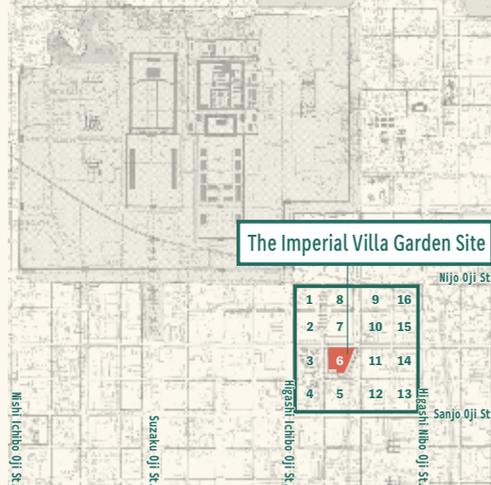
The Jobo city structure of the Heijokyo Capital and the Imperial Villa Garden

The city of the Heijokyo Capital followed a grid pattern in which large roads and streets crossed at right angles at many locations. Each block separated by the roads and streets was called “Jo,” “Bo,” or “Tsubo.” The garden was well-designed within a one “Tsubo” section and skillfully utilized the entire site for all its buildings and walls.

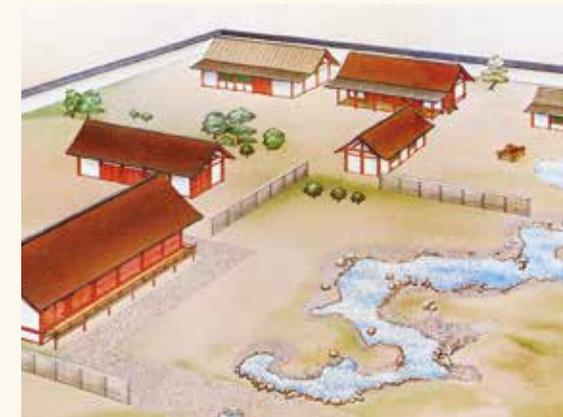
Imaginary picture of the restored garden

The remains of the buildings and walls discovered around the pond were backfilled for preservation purposes and restored buildings or flat displays depict its original appearance.
