# Hiroshima Prefectural Industrial Promotion Hall and Atomic Bomb Hypocenter

- Hiroshima -

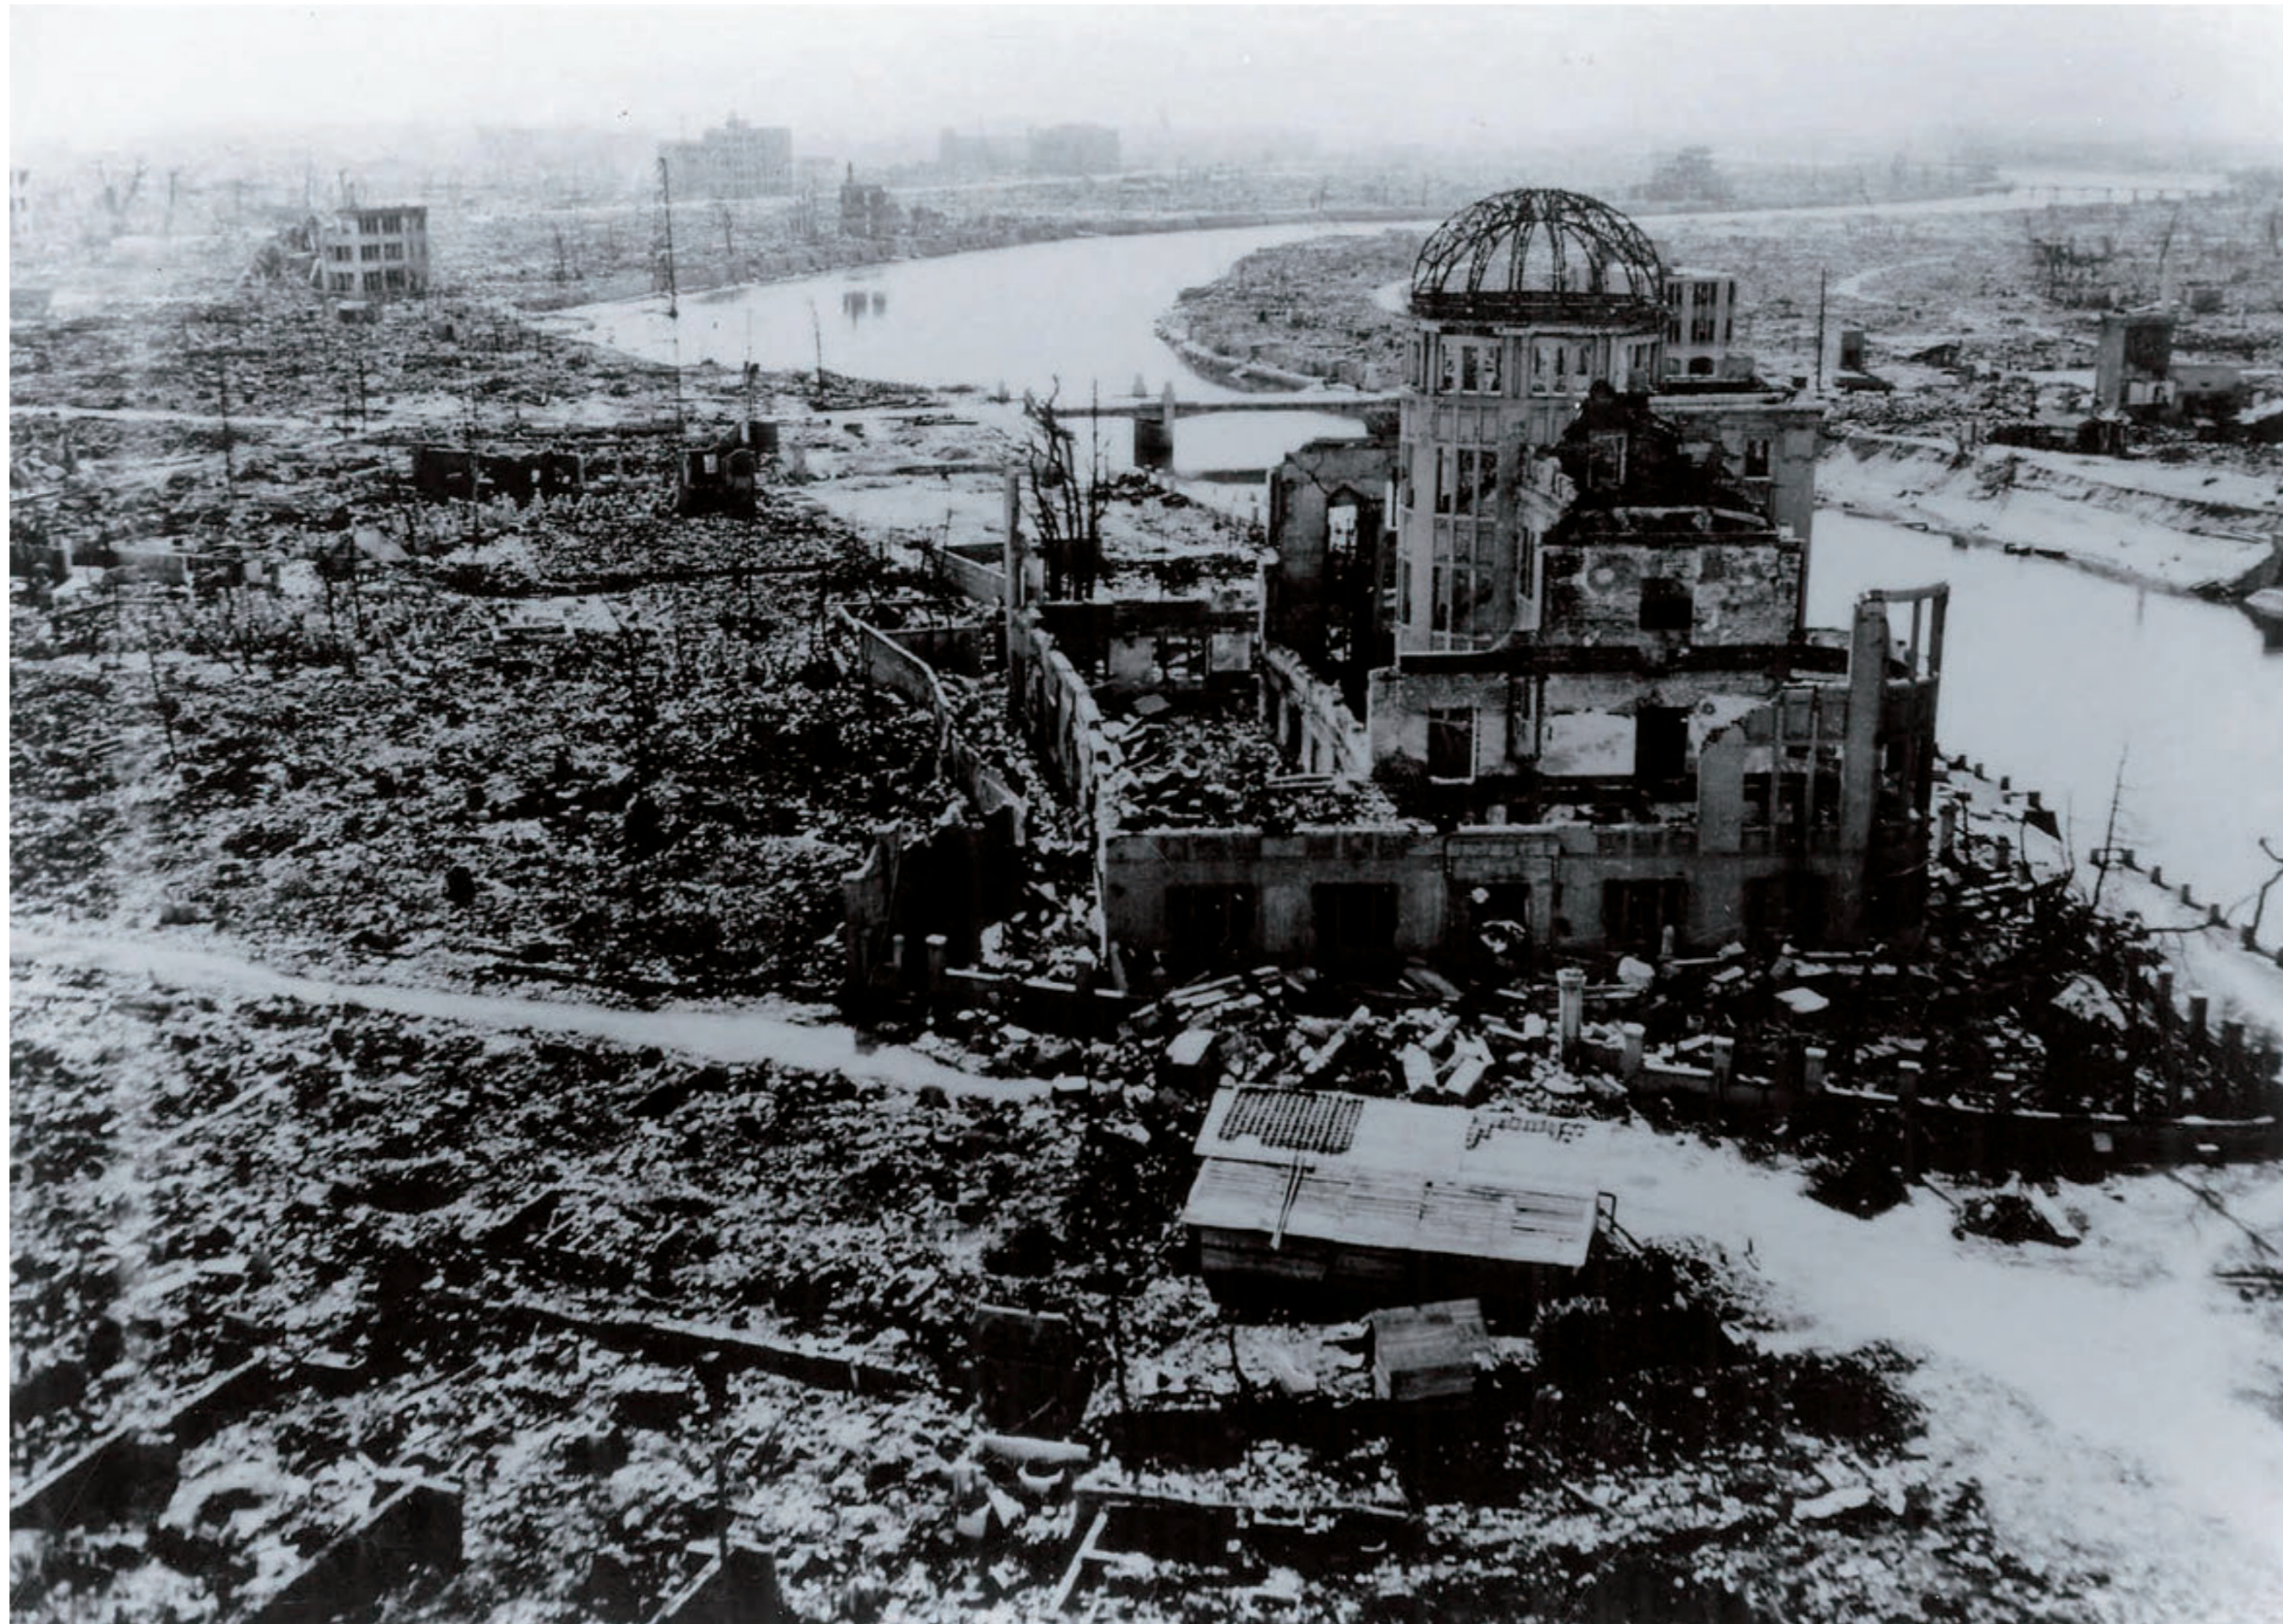
In an instant, the atomic bomb caused fire to burst up through the ceiling, completely burning the building. However, because the bomb exploded almost directly above here, the main part of the building miraculously withstood the blast.

The remaining walls and the exposed iron frame of the dome remain as a symbol of the atomic bombing as what is now called the Atomic Bomb Dome.

Distance from Hypocenter: 260m  
Photographed by American Military (from Roof of Commerce and Economic Committee of Hiroshima Building)  
Date of Photograph: November 1945  
Source: Hiroshima Peace Museum
